**Flood Control Project Maintenance  
Levee Inspections**

**Fall 2018 Levee Maintenance Deficiency Summary Report**

**Flood Control Project Maintenance  
Levee Inspections****LMA District Cover Sheet****Fall 2018 Levee Inspection Results****Eastern Honcut Creek**

**Eastern Honcut Creek**

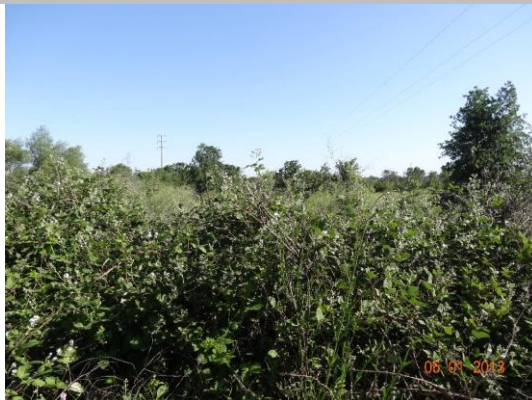
Photo 3 of 3 : UCIP\_FA\_2018\_52800\_24229.jpg

LM Start	0.01	Rating **	M	Issue No.	26 (cont)	
LM End	0.01	Issue Type +	Ma	Location *		
Category	Supplemental			GPS Latitude/Longitude		
				Start		End
Item	DWR UCIP LMA Responsibility			39.298484 °		39.298484 °
				-121.569610 °		-121.569610 °
DWR ID	19167					
Comment Code						
Inspector Comment						
FS_ID:52800						
DS_ID:19167						
EP_NO: N/A						
Repair Type: Non-Urgent						
Crossing Status: Found						
UCIP Comments: 05/01/2013 Dense vegetation on landward side obstructs inspection. Vegetation needs to be cleared to perform utility crossing inspection. (DWR UCIP - O. Magana)						
FIELD_STRUCT_DESC: 24-inch corrugated metal drainage pipe through the levee, 12 feet below the crown. Flap gate located on the waterside (WS) end. [Additional Reference(s): DWR Levee Logs, 2005. USACE Sacramento O&M Manual Unit No. 151, November 1953, (Station 0+60)]						
FS Date: 5/1/2013

Dense vegetation on waterward side obstructing inspection.

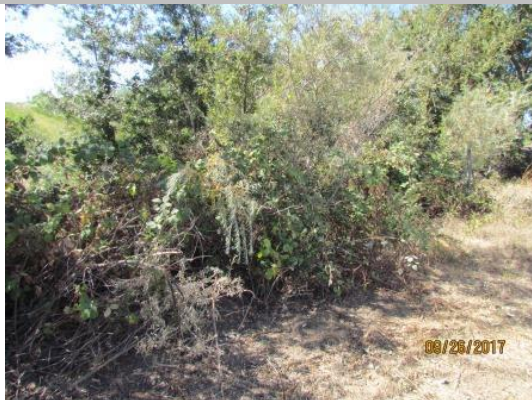
Photo 1 of 1 : FA\_2018\_NA0006\_252\_8\_20180918\_00002.jpg

LM Start	0.02	Rating **	U	Issue No.	8
LM End	0.06	Issue Type +	Ma	Location *	LS
Category	Earthen Levee			GPS Latitude/Longitude	
				Start	End
Item	Vegetation			39.298486 °	39.299052 °
				-121.569504 °	-121.569277 °
DWR ID	DWR_NA0006_01_s_2017_8				
Comment Code					
V2 : Remove the wild growth other than native grasses from the levee slopes.					
Inspector Comment					
Broad leaf thistle and bushes covering landside slope, Fall 2018.

View looking downstream of broad leaf thistle &amp; bushes covering landside slope, Fall 2017.

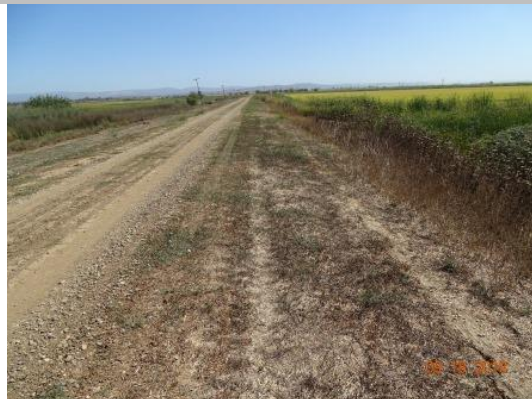
Photo 1 of 1 : FA\_2018\_NA0006\_252\_11\_20181003\_00030.jpg

LM Start	0.07	Rating **	A	Issue No.	11
LM End	0.83	Issue Type +	Ma	Location *	LS
Category	Earthen Levee			GPS Latitude/Longitude	
				Start	End
Item	Vegetation			39.299127 °	39.295192 °
				-121.569096 °	-121.558028 °
DWR ID	DWR_NA0006_01_f_2018_11				
Comment Code					
V1 : Control annual grass and weeds on the levee slopes and easements.					
Inspector Comment					
The annual vegetation is well maintained in this section, Fall 2018.

View looking upstream landside at the well maintained annual vegetation, Fall 2018.

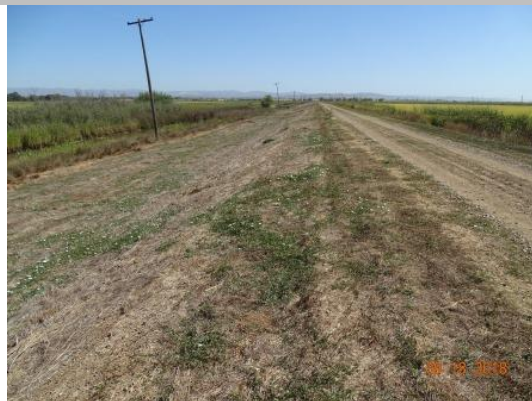
Photo 1 of 1 : FA\_2018\_NA0006\_252\_12\_20181003\_00031.jpg

LM Start	0.07	Rating **	A	Issue No.	12
LM End	0.83	Issue Type +	Ma	Location *	WS
Category	Earthen Levee			GPS Latitude/Longitude	
				Start	End
Item	Vegetation			39.299127°	39.295192°
				-121.569096°	-121.558028°
DWR ID	DWR_NA0006_01_f_2018_12				
Comment Code					
V1 : Control annual grass and weeds on the levee slopes and easements.					
Inspector Comment					
The annual vegetation is well maintained in this section, Fall 2018.

View looking upstream waterside at the well maintained annual vegetation, Fall 2018.

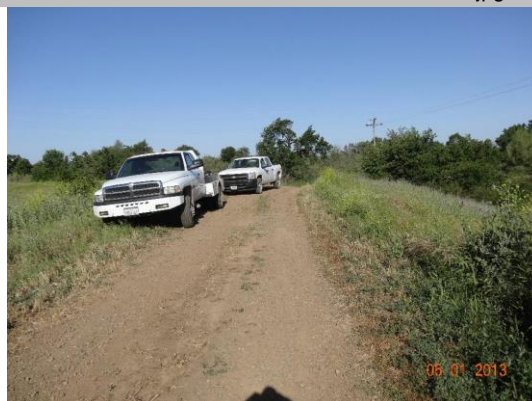
Photo 1 of 3 : UCIP\_FA\_2018\_52801\_24241.jpg

LM Start	0.09	Rating **	M	Issue No.	27
LM End	0.09	Issue Type +	Ma	Location *	
Category	Supplemental			GPS Latitude/Longitude	
				Start	End
Item	DWR UCIP LMA Responsibility			39.299106 °	39.299106 °
				-121.568749 °	-121.568749 °
DWR ID	19168				
Comment Code					
Inspector Comment					
FS_ID:52801 DS_ID:19168 EP_NO: N/A Repair Type: Non-Urgent Crossing Status: Found UCIP Comments: 05/01/2013 Dense vegetation on waterward side and landward side obstructs inspection. Need to clear vegetation on slopes to conduct proper crossing evaluation. (DWR UCIP - O. Magana) FIELD_STRUCT_DESC: 24-inch corrugated metal drainage pipe through the levee, 10 feet below the crown. Flap gate located on the waterside (WS) end. [Additional Reference(s): DWR Levee Logs, 2005. USACE Sacramento O&M Manual Unit No. 151, November 1953, (Station 5+65)] FS Date: 5/1/2013

Overview of levee crown at crossing looking upstream.

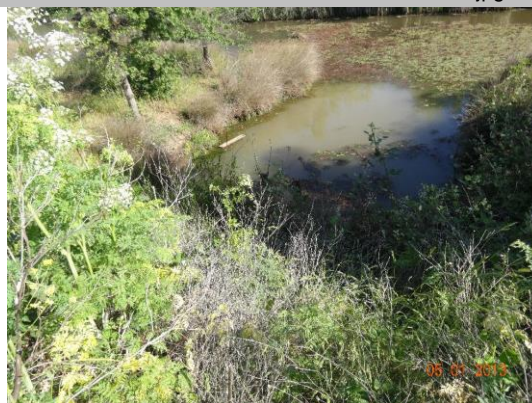
Photo 3 of 3 : UCIP\_FA\_2018\_52801\_24238.jpg

Comment Code						
Inspector Comment						
FS_ID:52801						
DS_ID:19168						
EP_NO: N/A						
Repair Type: Non-Urgent						
Crossing Status: Found						
UCIP Comments: 05/01/2013 Dense vegetation on waterward side and landward side obstructs inspection. Need to clear vegetation on slopes to conduct proper crossing evaluation. (DWR UCIP - O. Magana)						
FIELD_STRUCT_DESC: 24-inch corrugated metal drainage pipe through the levee, 10 feet below the crown. Flap gate located on the waterside (WS) end. [Additional Reference(s): DWR Levee Logs, 2005. USACE Sacramento O&M Manual Unit No. 151, November 1953, (Station 5+65)]						
FS Date: 5/1/2013

Overview of waterward side (outlet).

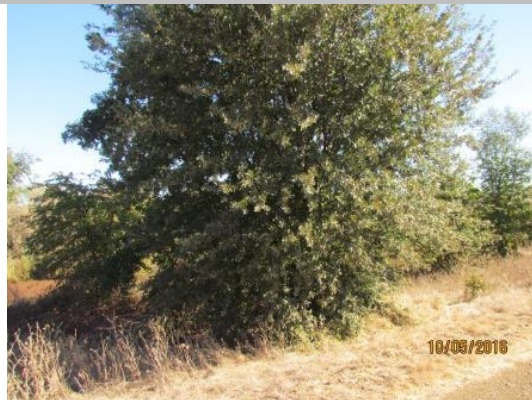
Photo 1 of 1 : FA\_2018\_NA0006\_252\_22\_20180918\_00008.jpg

LM Start	0.10	Rating **	M	Issue No.	22
LM End	0.10	Issue Type +	Ma	Location *	WS
Category	Earthen Levee			GPS Latitude/Longitude	
				Start	End
Item	Trim / Thin Trees			39.299078 °	39.299078 °
				-121.568633 °	-121.568633 °
DWR ID	DWR_NA0006_01_f_2016_22				
Comment Code					
T1 : Trim trees to at least five feet above ground level.					
Inspector Comment					
A tree that needs the limbs trimmed up 5' for visibility and access on the waterside. Fall 2018.

View of a tree that needs the limbs trimmed up 5' for visibility and access on the waterside. Fall 2016.

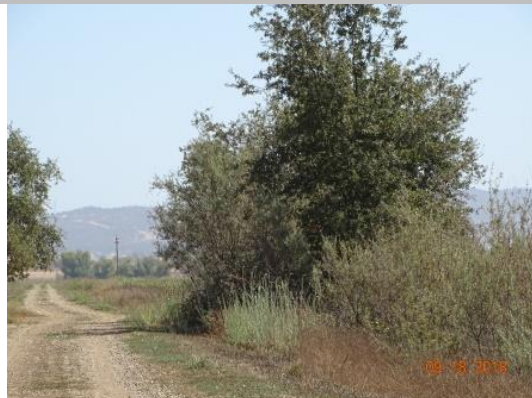
Photo 1 of 1 : FA\_2018\_NA0006\_252\_23\_20181003\_00027.jpg

LM Start	0.21	Rating **	U	Issue No.	23
LM End	0.21	Issue Type +	Ma	Location *	LS
Category	Earthen Levee			GPS Latitude/Longitude	
				Start	End
Item	Trim / Thin Trees			39.298816 °	39.298816 °
				-121.566529 °	-121.566529 °
DWR ID	DWR_NA0006_01_f_2016_23				
Comment Code					
T3 : Trim and thin trees to allow visibility of the ground and room to flood fight.					
Inspector Comment					
Trees that needs the limbs trimmed up 5' for visibility and access on the landside. Fall 2018.

View looking upstream landside of trees that needs the limbs trimmed up 5' for visibility and access on the landside, Fall 2018.

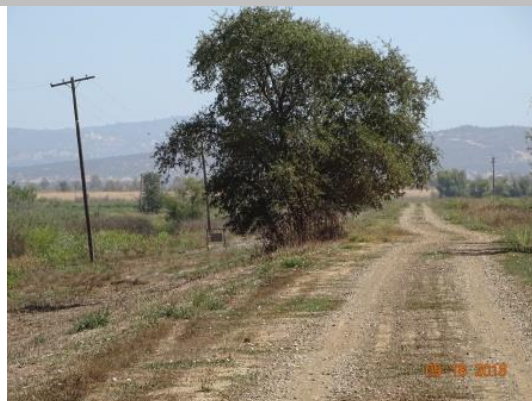
Photo 1 of 1 : FA\_2018\_NA0006\_252\_25\_20181003\_00028.jpg

LM Start	0.23	Rating **	M	Issue No.	25
LM End	0.23	Issue Type +	Ma	Location *	WS
Category	Earthen Levee			GPS Latitude/Longitude	
				Start	End
Item	Trim / Thin Trees			39.298776 °	39.298776 °
				-121.566158 °	-121.566158 °
DWR ID	DWR_NA0006_01_f_2016_25				
Comment Code					
T1 : Trim trees to at least five feet above ground level.					
Inspector Comment					
Tree that needs the limbs trimmed up 5' for visibility and access on the waterside. Fall 2018.

View looking upstream waterside of a tree that needs the limbs trimmed up 5' for visibility and access on the waterside, Fall 2018.

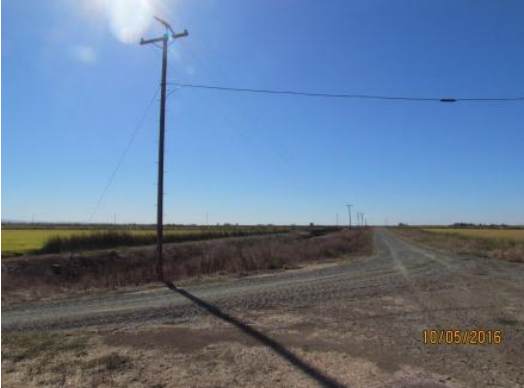
Photo 1 of 1 : FA\_20180918\_00004.jpg

View of the poleline on the waterside of the levee facing upstream. Fall 2016.

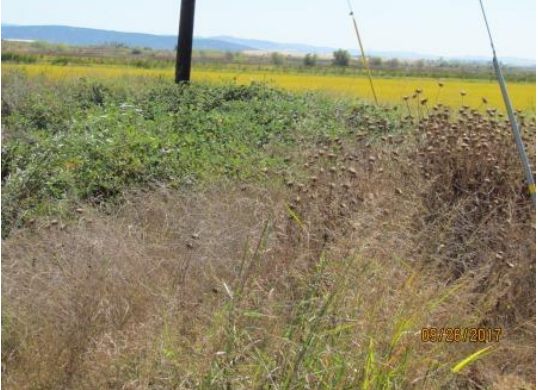
Photo 1 of 1 : FA\_2018\_NA0006\_252\_1\_20180918\_00001.jpg

View of Blackberry bushes that are starting to cover the waterside slope.  
Looking upstream waterside, Fall 2017.

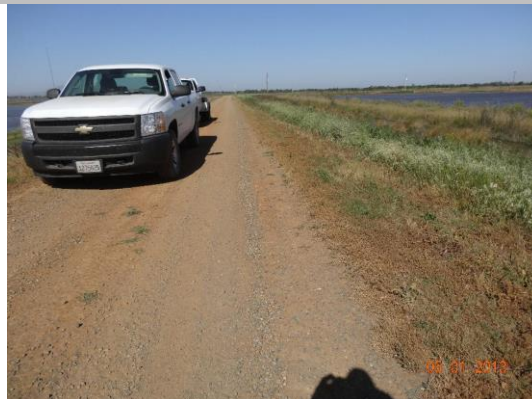
Photo 1 of 3 : UCIP\_FA\_2018\_52802\_24253.jpg

FS\_ID:52802  
DS\_ID:19172  
EP\_NO: 9610  
Repair Type: Non-Urgent  
Crossing Status: Found  
UCIP Comments: 05/01/2013 Scouring occurring directly across pipe on access road. Need to determine permit authorizing updates to crossing. Crossing appears to be no more than 10 years old. (DWR UCIP - O. Magana)  
FIELD\_STRUCT\_DESC: 1 of 2: 24-inch corrugated metal irrigation pipe through the levee, 6 feet below the crown. Slide gates are installed on waterside (WS) end of pipe. (two 24-inch pipe authorized Permit No. 9610, 1974-Honcut Creek Ranch). [Additional Reference(s): DWR Levee Logs, 2005. USACE Sacramento O&M Manual Unit No. 151, November 1953, (Station 53+70)]  
FS Date: 5/1/2013

Overview of levee crown looking upstream at crossing.

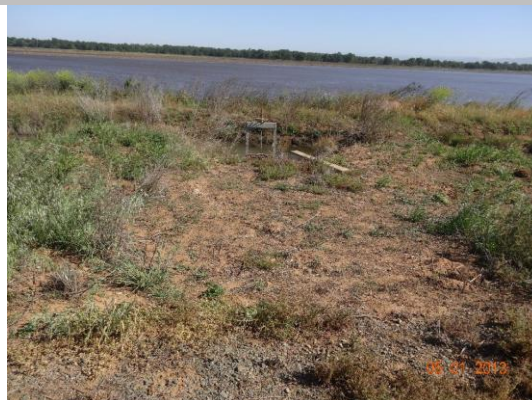
Photo 2 of 3 : UCIP\_FA\_2018\_52802\_24252.jpg

View of waterward side.

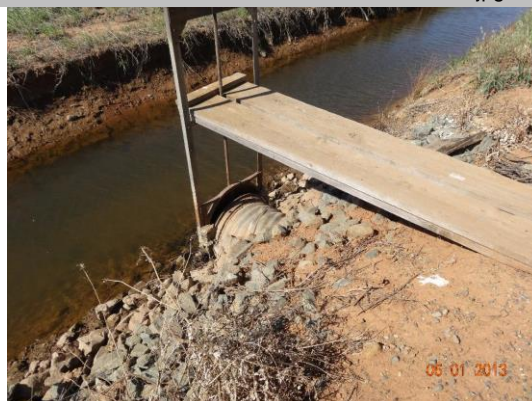
Photo 2 of 3 : UCIP\_FA\_2018\_52803\_24258.jpg

LM Start	1.17	Rating **	M	Issue No.	29 (cont)
LM End	1.17	Issue Type +	En	Location *	
Category	Supplemental			GPS Latitude/Longitude	
				Start	End
Item	DWR UCIP Field Study			39.295099 °	39.295099 °
				-121.551839 °	-121.551839 °
DWR ID	19174				
Comment Code					
Inspector Comment					
FS_ID:52803 DS_ID:19174 EP_NO: N/A Repair Type: Non-Urgent Crossing Status: Found UCIP Comments: 05/01/2013 Recent repair will need to contact owner to follow-up. (DWR UCIP - O. Magana) FIELD_STRUCT_DESC: 24-inch corrugated metal drainage pipe through the levee, 10 feet below the crown. Flap gate located on the waterside (WS). FS Date: 5/1/2013

View of landward side: positive closure device, walkway, and rip rap on slope.

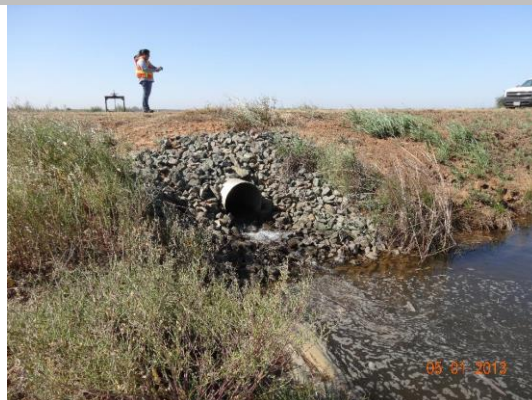
Photo 3 of 3 : UCIP\_FA\_2018\_52803\_24257.jpg

View of waterward side crossing looks fairly new.

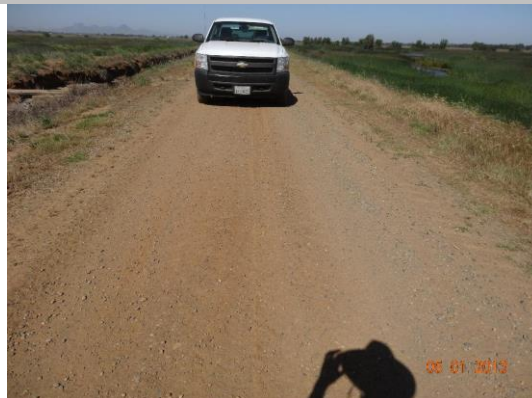
Photo 1 of 3 : UCIP\_FA\_2018\_52804\_24275.jpg

LM Start	1.44	Rating **	M	Issue No.	30
LM End	1.44	Issue Type +	En	Location *	
Category	Supplemental			GPS Latitude/Longitude	
				Start	End
Item	DWR UCIP Field Study			39.295238 °	39.295238 °
				-121.546755 °	-121.546755 °
DWR ID	19169				
Comment Code					
Inspector Comment					
FS_ID:52804					
DS_ID:19169					
EP_NO: N/A					
Repair Type: Non-Urgent					
Crossing Status: Found					
UCIP Comments: 05/01/2013 Need to determine permit authorizing work. (DWR UCIP - O. Magana)					
FIELD_STRUCT_DESC: 18-inch corrugated metal irrigation pipe through the levee, 8 feet below the crown. Slide gate located on the landside (LS) end. Rock revetment on the LS near slide-gate.					
[Additional Reference(s): DWR Levee Logs, 2005]					
FS Date: 5/1/2013

View of levee crown looking upstream at crossing.

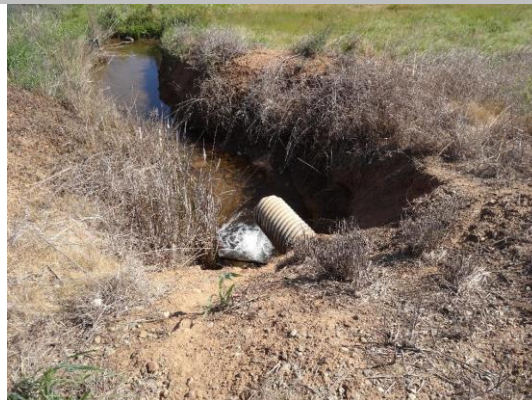
Photo 3 of 3 : UCIP\_FA\_2018\_52804\_24274.jpg

LM Start	1.44	Rating **	M	Issue No.	30 (cont)	
LM End	1.44	Issue Type +	En	Location *		
Category	Supplemental			GPS Latitude/Longitude		
				Start	End	
Item	DWR UCIP Field Study			39.295238 °	39.295238 °	
				-121.546755 °	-121.546755 °	
DWR ID	19169					
Comment Code						
Inspector Comment						
FS_ID:52804						
DS_ID:19169						
EP_NO: N/A						
Repair Type: Non-Urgent						
Crossing Status: Found						
UCIP Comments: 05/01/2013 Need to determine permit authorizing work. (DWR UCIP - O. Magana)						
FIELD_STRUCT_DESC: 18-inch corrugated metal irrigation pipe through the levee, 8 feet below the crown. Slide gate located on the landside (LS) end. Rock revetment on the LS near slide-gate.						
[Additional Reference(s): DWR Levee Logs, 2005]						
FS Date: 5/1/2013

Crossing visible on waterward side.
